Application to the Littlehampton Harbour Board for permission under S43 of The Littlehampton Harbour and Arun Drainage Outfall Act 1927 to undertake works on the West Side of the Littlehampton Harbour at the Arun Timber Docks (ATD) South Dock.

Arun Timber Docks; removal of decaying existing wooden piles and installation of new steel piles and pontoons.

SOUTH DOCK – CONDITION SURVEY

SEPTEMBER 2015

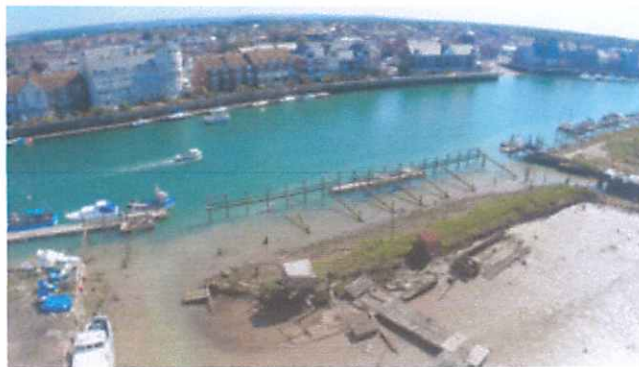
The image below shows the docks today with the remnants of the revetment. Note the erosion leading to the gap between the piles and the dry land.

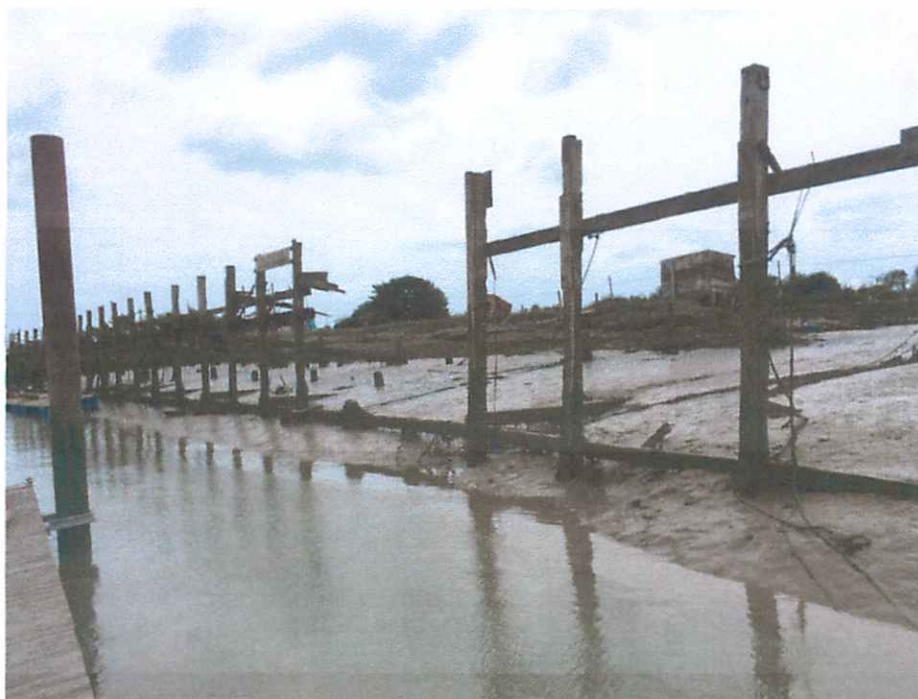
In recent years the primary purpose of the revetment (to assist in maintaining the navigation channel and prevent flooding) has reduced due to its condition. The image on the next page shows the current condition of the structure.

However, despite its condition the lower section of the structure will have some impact in retaining the bank. This is more likely to be due to the attenuation of the tidal velocities locally rather than physically holding the mud.

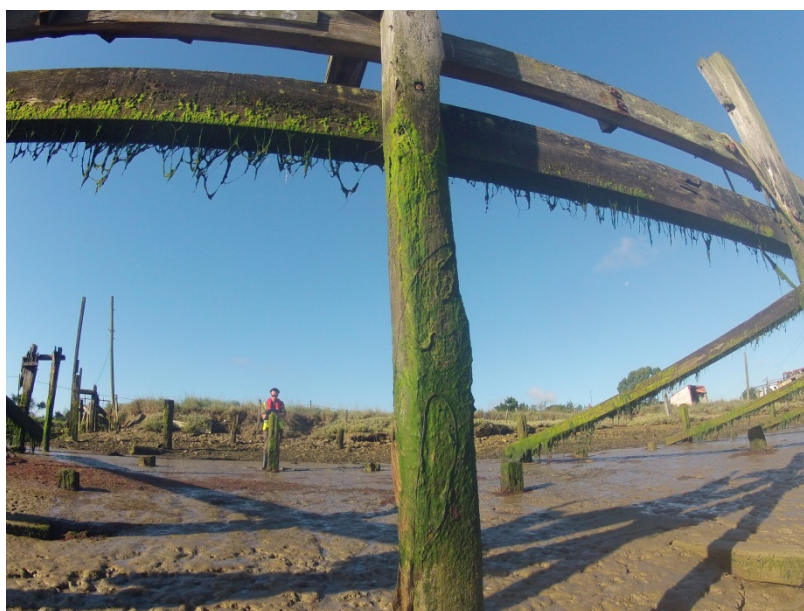
Physical deterioration (Figure 1) was observed. Deterioration mechanisms observed here could be a combination of the following:

- Timber decay and marine borer activity;
- Corrosion and fretting of connections;
- Splitting and general wear;
- Abrasion due to moving debris or items attached to the structure such as mooring lines;
- Damage from vessel impact in the river; and
- Softening due to water penetration and increased moisture content.

Figure 1 - Typical evidence of Physical Deterioration.

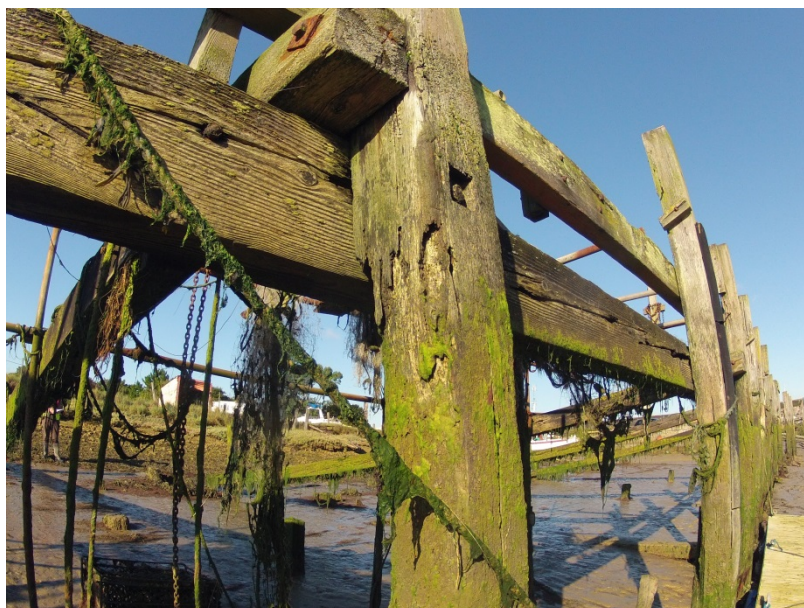
Biological deterioration (Figure 2) was also observed. Deterioration mechanisms here could consist of wood-destroying organisms that infest the timber above and below the waterline. In this case Marine Borers commonly pose issues for waterside timber structures.

In British temperate waters two types of marine borers are common; the gribble (*Limnoria*) and the shipworm (*Teredo*). Shipworm burrow into timber materials, generally below mid tide level and can penetrate to depths over 500mm. Extensive attack from gribble weakens the surface of timber until it is eroded away. Few timbers are entirely immune to marine attack but the marine grade timber thought to be used for the original staging structure is typically highly resistant.

Figure 2 - Typical evidence of marine borer activity.

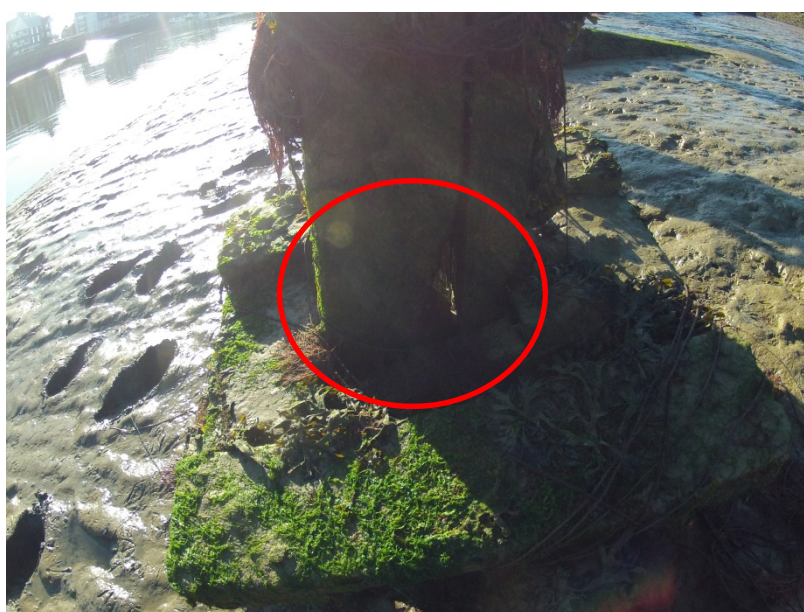
- Pile P7 which has timber debris around the base of the pile which is mobile when lifted. This is thought to be causing accelerated abrasion around the base of the pile, with an almost circular section remaining of approximately 150-200mm in diameter as seen in Figure 3.
- Piles P5 and P6 which are cut at bed level (Figure 4).

Figure 3 - Significant abrasion identified on P7.

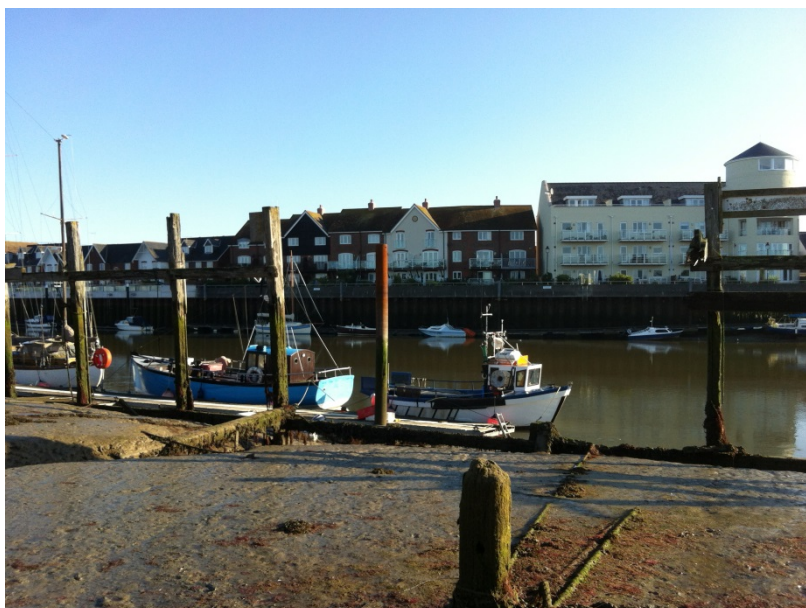
2no. vertical timber piles (5 and 6) appear to have been cut and removed at bed level as observed at low tide. These piles have evidently been considered redundant in the past and their removal provides an access channel to the intertidal basin behind the structure.

Figure 4 - Piles P5 and P6 cut at bed level for vessel access.

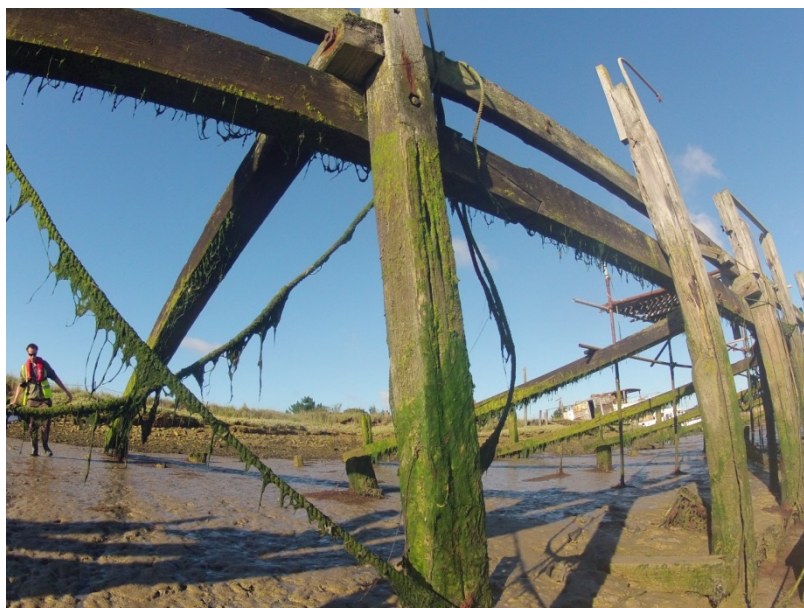
Splitting has been observed in numerous piles. The cause of splitting is not known however typically the splitting of waterside timber structures may be due to overloading in the past as a result of berthing and mooring loads from vessels using the staging. This is expected to be in combination with other deterioration mechanisms which have weakened the timber pile sections such as wetting and drying and freeze-thaw damage (see Figure 5). Splitting is a sign of significant weakening due to a combination of effects and is particularly concerning when biological deterioration is commonly increased around splits.

Figure 5 - Typical splitting of timber piles.

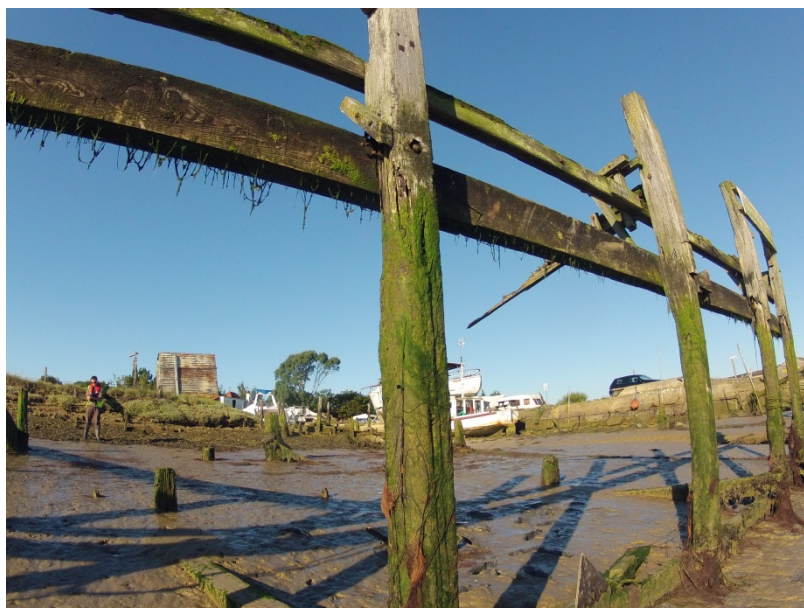
At either extreme ends (P1 and P25), the original props still exist. At piles P3, P7 and P9 the rakers have broken off with only debris remaining (Figure 6), which may pose a hazard to safe navigation in the intertidal basin.

Figure 6 - Debris of original raked prop at high level on P9.

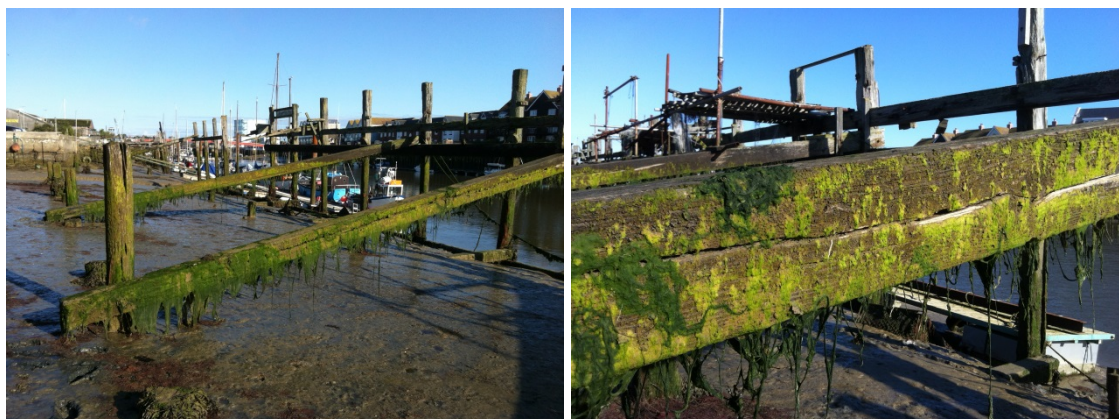
Newer rakers are typically split along the grain with marine borers causing further progressive deterioration possibly suggesting a less appropriate timber specification for the use.

It is assumed that the previous strengthening of this mooring stage was carried out with the purpose of prolonging its serviceable life and to permit the safe berthing of larger fishing vessels where previous operations may have caused damage. It is unknown when strengthening works took place, however the evidence of splitting and decay indicate that the quality of timber used is lower than that of the original structure. As such, berthing and mooring has caused compressive damage and in some cases failure of the newer rakers as shown in Figure 7(a) and (b).

Figure 7(a) & (b) - Examples of split rakers.

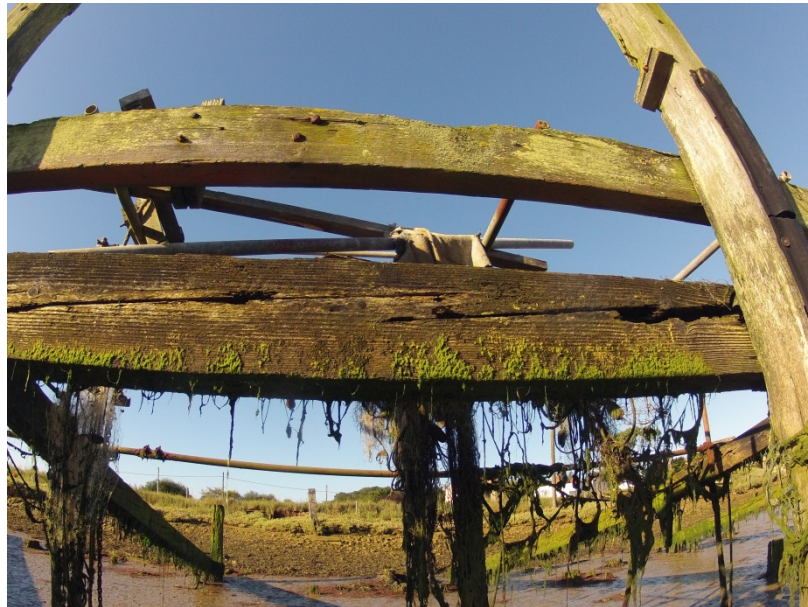
The larger and more recent beam supporting newer rakers is generally in good condition. There is some splitting from possible vessel impact during operation (Figure 8); however there appears to be minimal section loss.

Figure 8 - Splitting of horizontal beam between P16-P17.

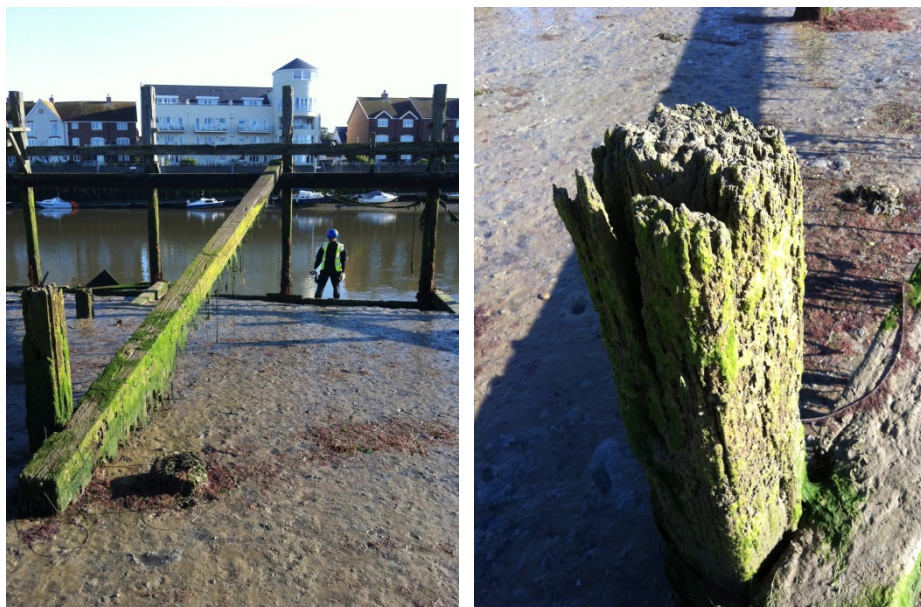
Above surface however, connections between anchor piles and rakers are visible. Connections show deterioration around through-bolts and bolt holes in the timber due to concentrations of marine growth, biological factors and abrasion from likely movement during operation of the mooring stage. The tops of anchor piles show significant deterioration, both physical and biological as shown in Figure 9(b).

Figure 9(a) & (b) Anchor piles and typical deterioration.
